KOP 11
Highway 306

Figure 3.9-12

Falcon to Gonder Project EIS

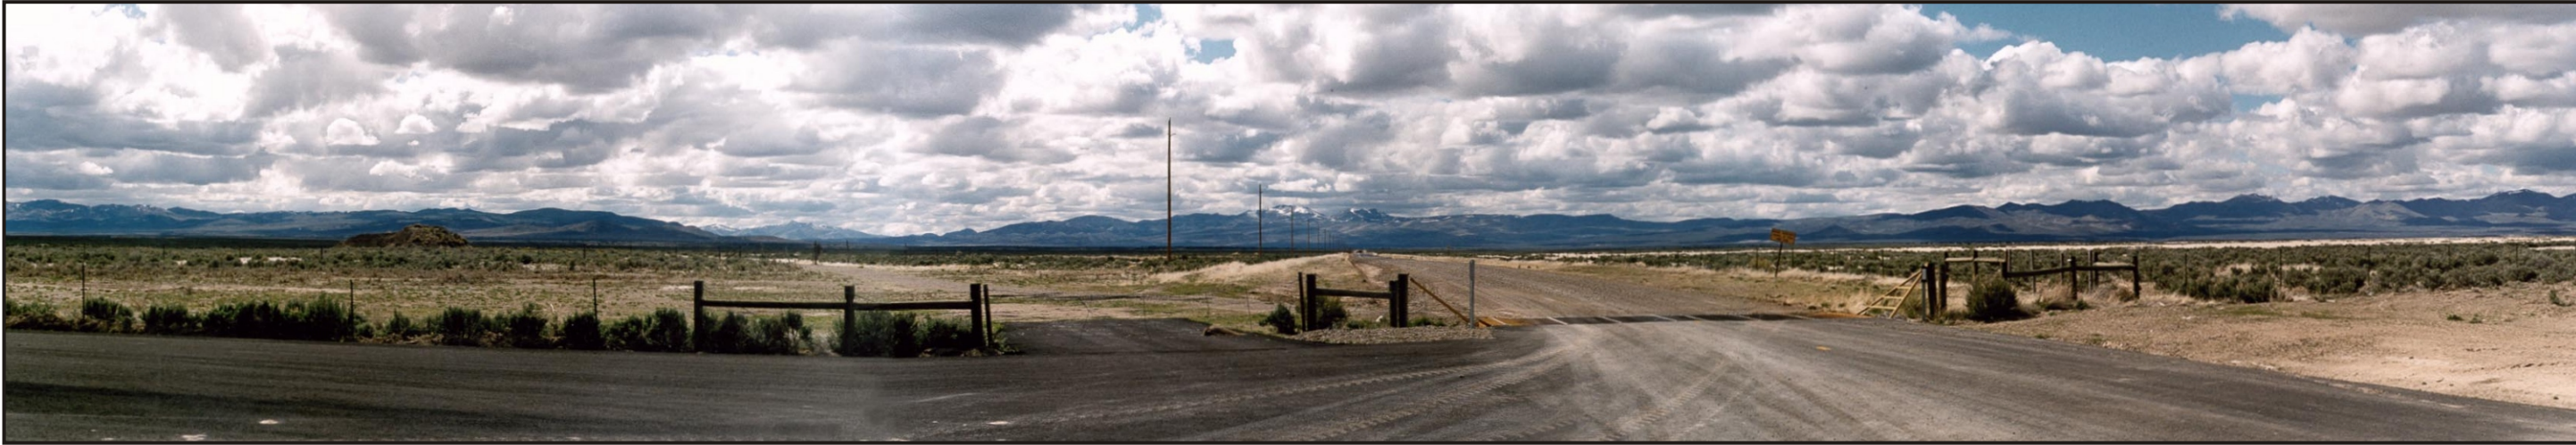
Existing Conditions

Type/Sensitivity of Users: Primarily local highway travelers with moderate sensitivity for visual quality
Volume of Users: Moderate
T/L Distance from Viewer: Middleground - approximately one-half mile
T/L Prominence in Landscape: Low - backdropped by mountain range and lower in landscape position
Existing Modifications: Gravel extraction pile, wood pole distribution line and rest area structures

Contrast Rating: Moderate
VRM Class: IV
Visual Impact Rating: Low

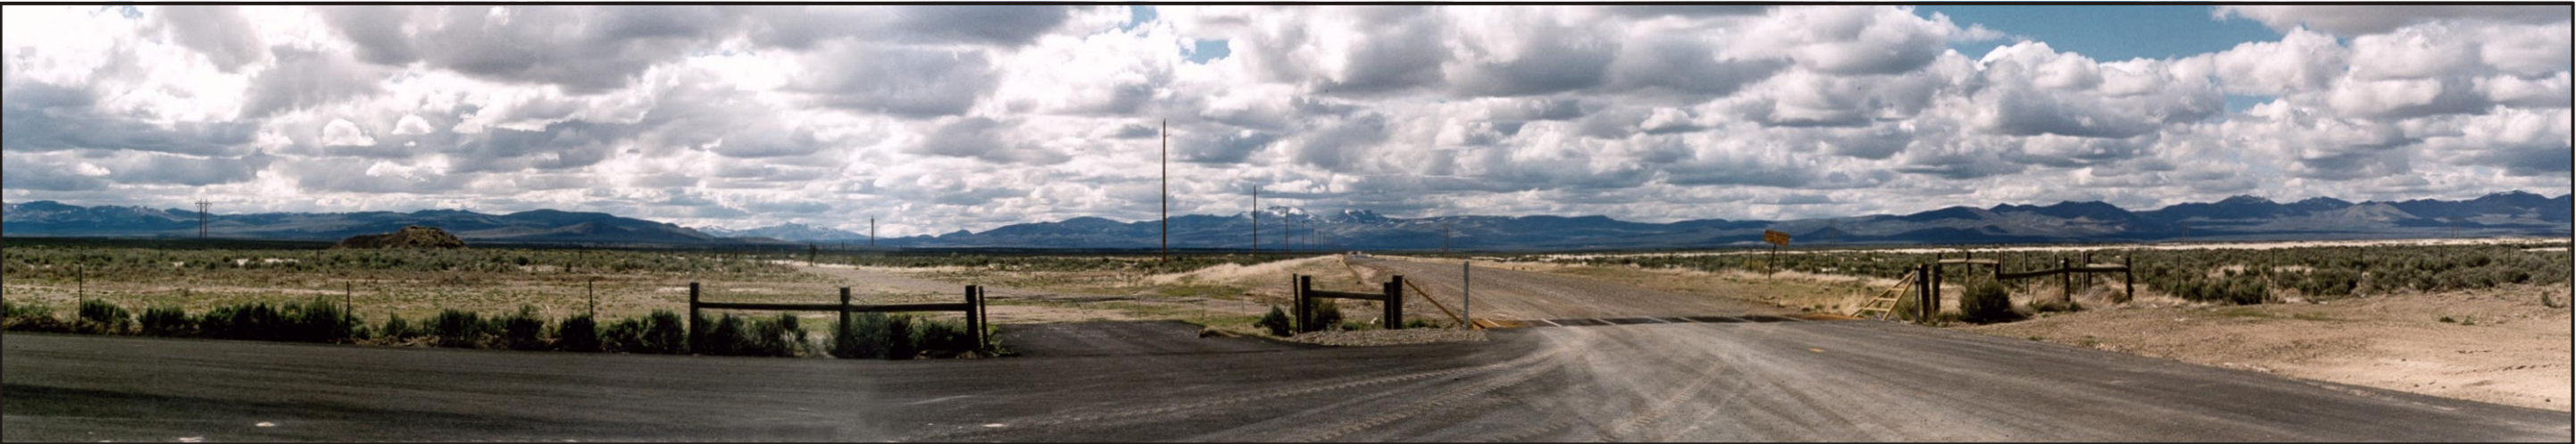
Future Conditions

Summary of Visual Changes
